INDOOR AIR QUALITY ASSESSMENT

**Career Opportunities
77 High School Road Extension
Hyannis, Massachusetts**

Prepared by:
Massachusetts Department of Public Health
Bureau of Environmental Health Assessment
Emergency Response/Indoor Air Quality Program
July 2003

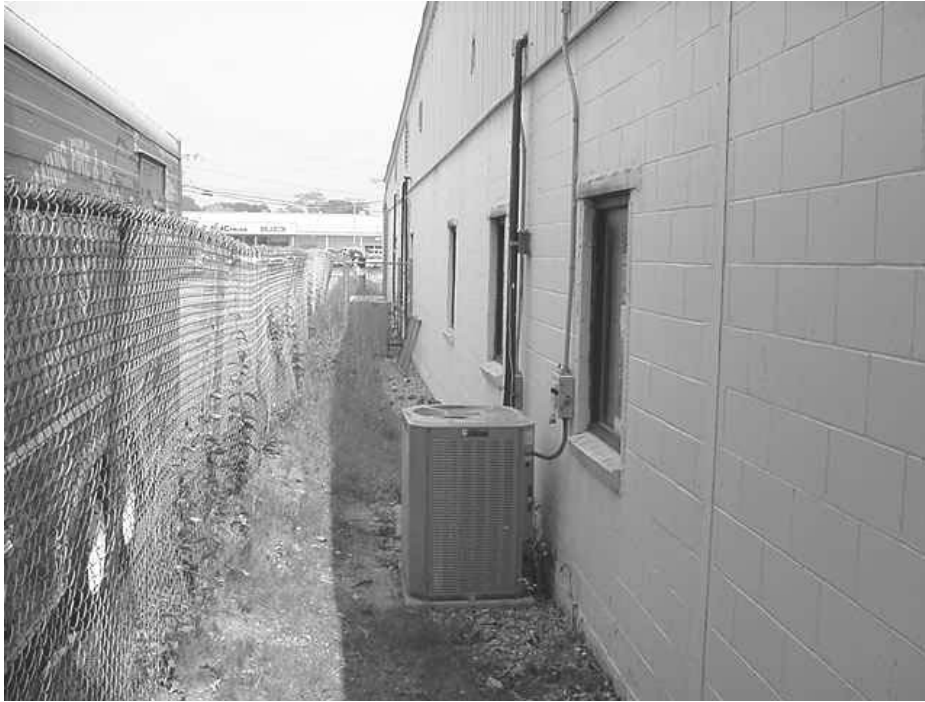
Picture 1

The building was constructed as an indoor roller skating rink in the late 1960s-early 1970s. The original structure consists of painted cinderblock exterior wall (see Picture 1), built on a cement slab. The original building was covered with a rubber membrane peaked roof (see Picture 2). It was converted into office space in 1998. It appears that the conversion included:

The Original Structure

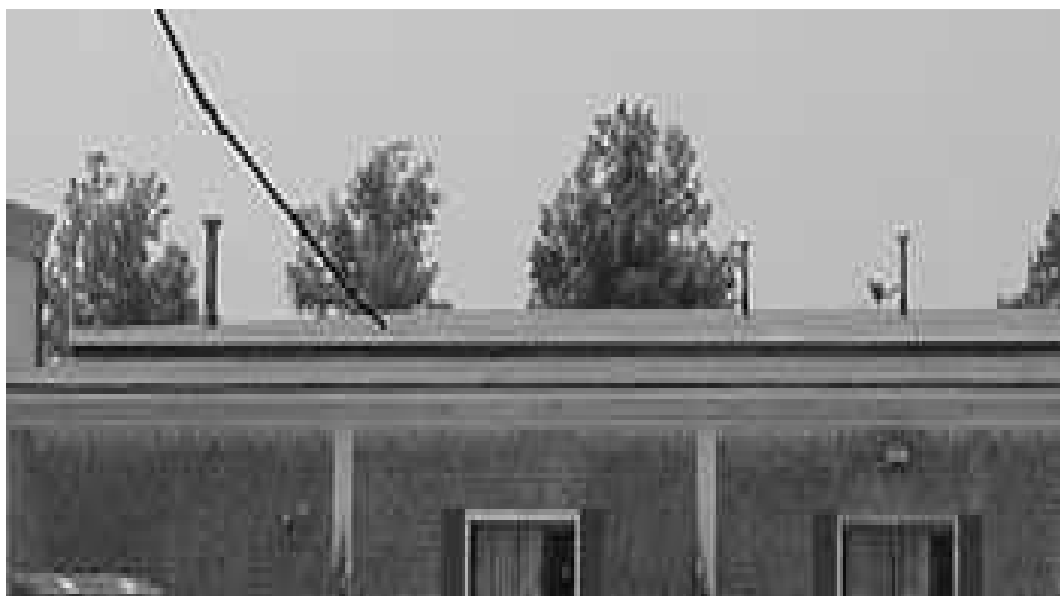
Picture 2

Rubber Membrane Peaked Roof Over Original Building

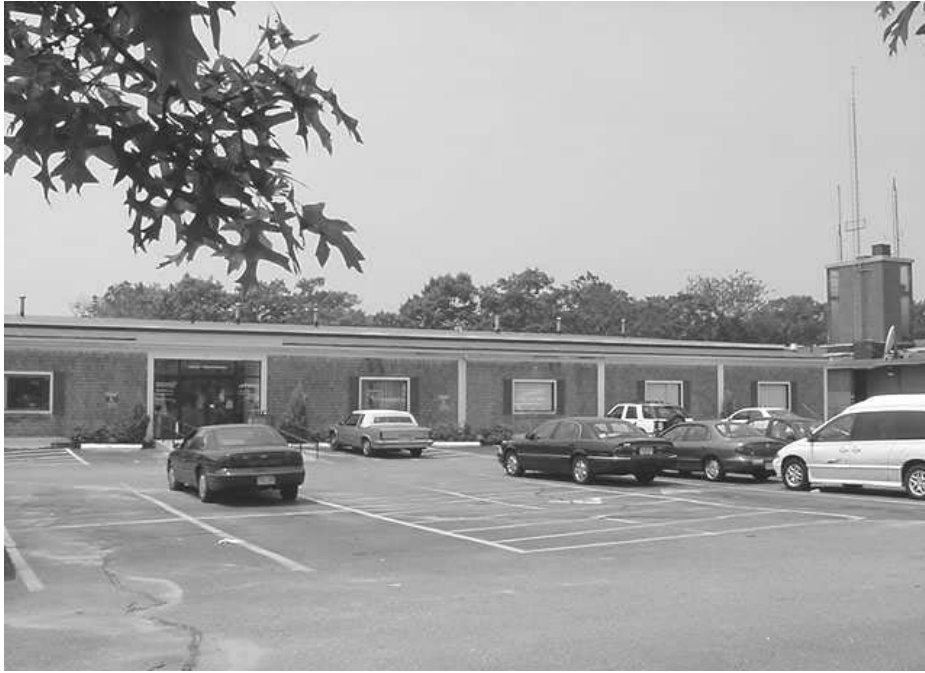
Picture 3

The Addition

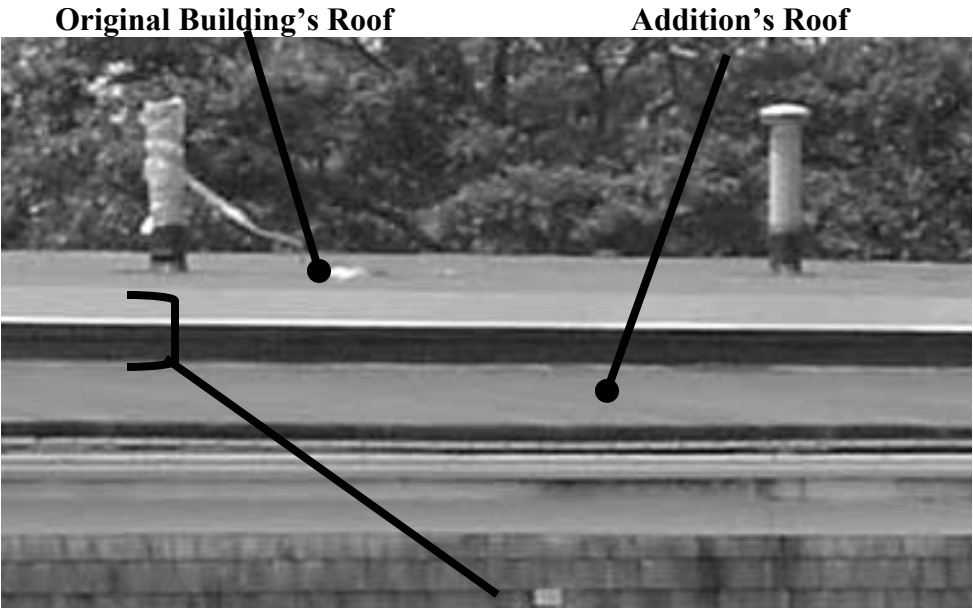
Picture 4

- Construction of an addition to the front of the building, thereby expanding the footprint to create more office space (see Picture 3);
- Installation of a roof for the aforementioned addition. Note, this new roof is installed below the edge of the original building's roof (see Picture 4);

Vertical Roof Section
The Original Building and Addition's Roof Junction

3. Properly seal all window frames and seams in exterior wall of original building.
4. Examine the feasibility of installing a gutter downspout system underneath the edge of the original building's roof at the front of the building.

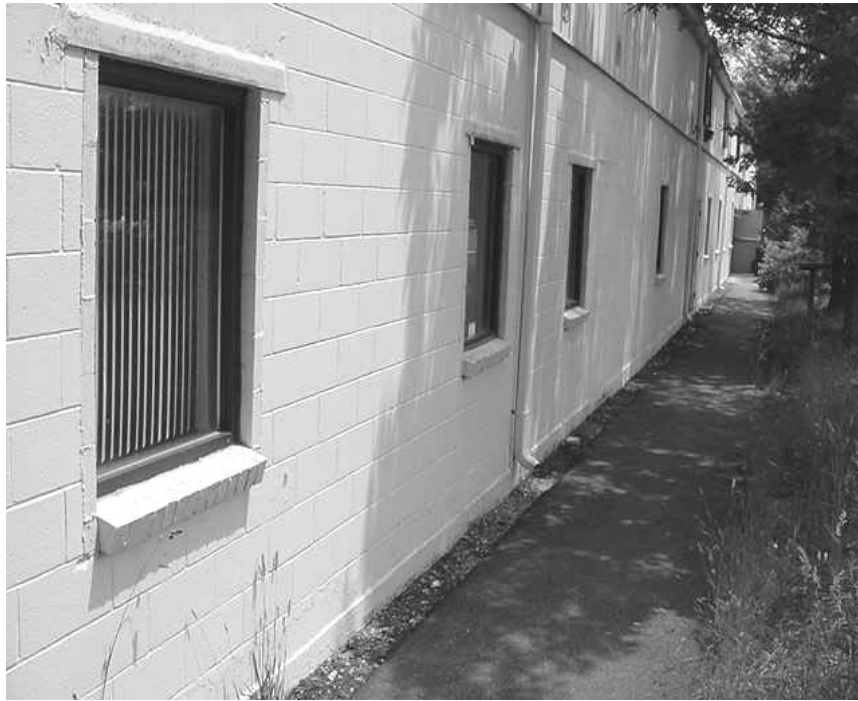
Picture 5

- Installation of heating ventilating and air conditioning (HVAC) equipment;
- Installation of windows in openings cut into existing cinder block walls (see Picture 5).

Windows Installed in Exterior Walls of Original Building

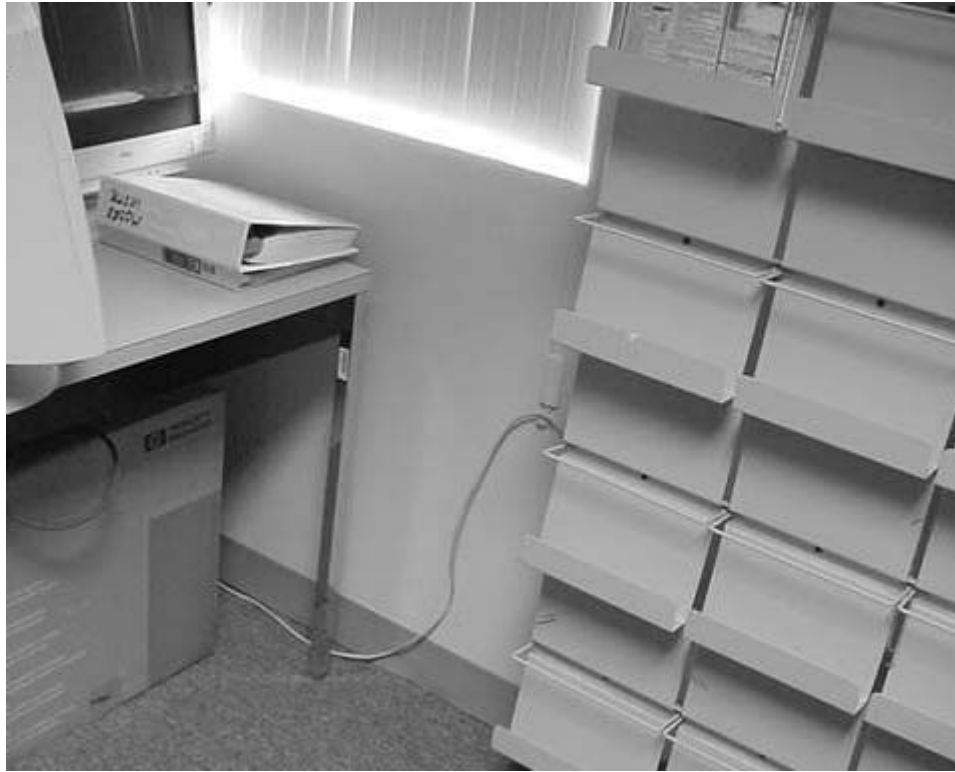
Picture 6

- Installation of gypsum wallboard (GW) along exterior cinder block walls to form interior walls and windowsills (see Picture 6); and
- Installation of wall-to-wall carpeting.

Gypsum Wallboard Installed In Manner to Form Windowsills

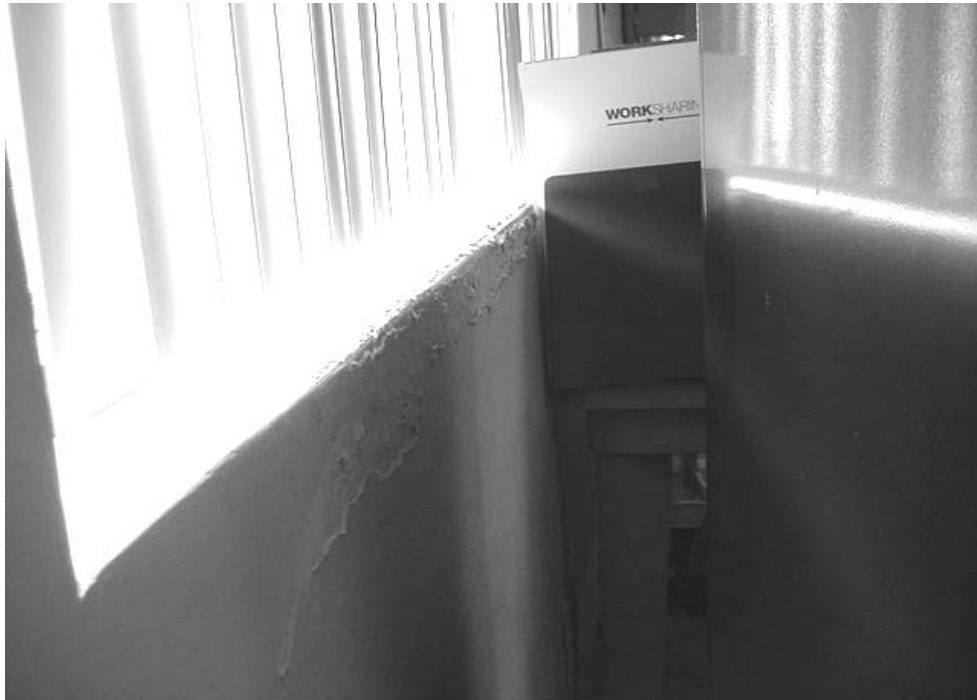
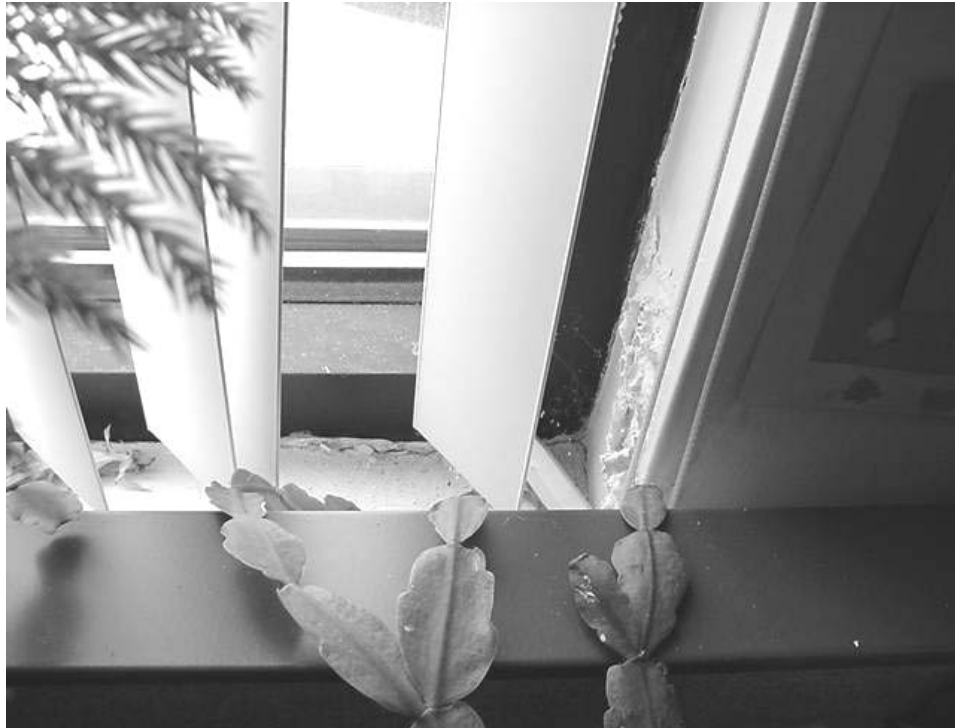
No active leaks were observed, however, accumulated moisture was noted on walls. GW windowsills on nearly every window throughout the building showed sign of bubbling and/or efflorescence (see Pictures 7 and 8). Efflorescence is a characteristic sign of water damage to building materials such as brick or plaster, but it is not mold growth. As moisture penetrates and works its way through mortar around brick, water-soluble compounds in bricks and mortar dissolve, creating a solution. As the solution moves to the surface of the brick or mortar, water

evaporates, leaving behind white, powdery mineral deposits. Carpeting beneath windows also appeared to be water stained.

Window Showed Sign of Bubbling and/or Efflorescence

1. Remove and replace any mold contaminated/water damaged GW, insulation, carpeting and ceiling tiles that are in either the ceiling system or along exterior walls and all affected window sills. This measure will remove actively growing mold colonies that may be present. Remove mold contaminated materials in a manner consistent with recommendations found in “Mold Remediation in Schools and Commercial Buildings” published by the US Environmental Protection Agency (US EPA, 2001).
2. Remove rubber baseboard coving during carpet removal and examine for fungal growth. If colonized with fungal growth, remove and replace up to six inches of GW along base of wall in accordance with recommendations found in “Mold Remediation in Schools and Commercial Buildings” (US EPA, 2001).

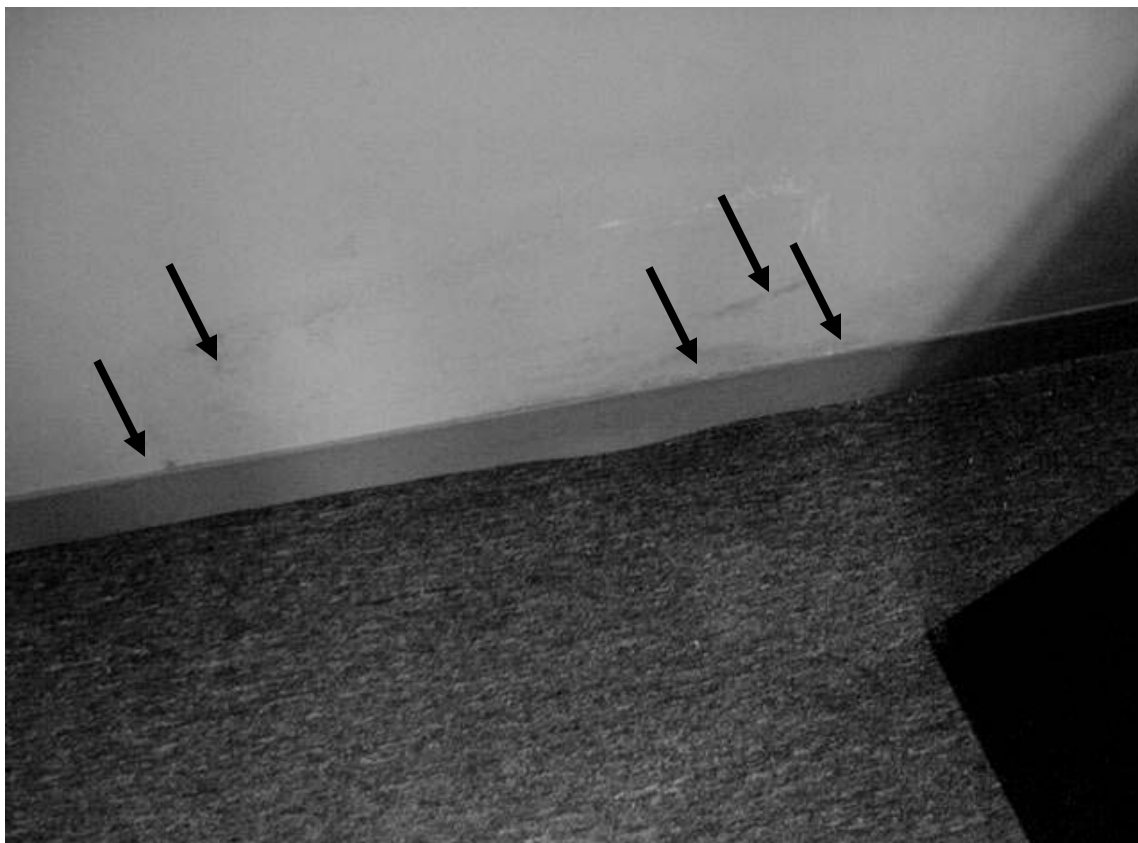
Picture 9

Additionally, Room 104 had visible mold growth on GW beneath the windowsill (see Picture 9). GW under window frames in rooms 104, 105 and 106 had moisture content measurements ≥ 0.6 percent around window frames. Moisture measurements indicate that GW under window frames was saturated. Other GW not adjacent to windows all had measurements below 0.5 percent. Of note was the moisture measurement taken through the plastic wall coving in room 106. This measurement indicates that GW below the plastic coving remained moistened for over 96 hours beyond the last rainstorm in Barnstable.

Possible Mold Colonization of GW in Room 104

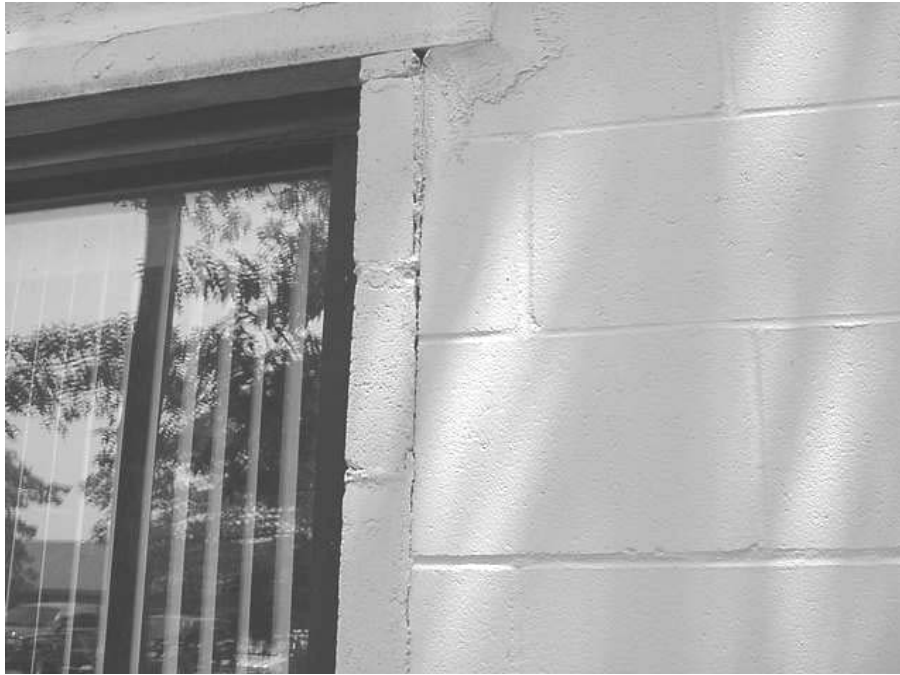
Picture 10a

Moisture in the indoor environment can originate from several sources. One possible source of moisture in GW may be introduction through leaks in window frames and spaces in the exterior walls. Window frames and sealed openings in exterior walls on the north south and west walls of the building had a number of holes or cracks in sealant seams that can allow water to penetrate into the interior of the building (see Pictures 10a and 10b). Spaces in window gaskets are also a pathway for moisture migration (see Picture 10c).

Original Building Windows with Holes around the Frames

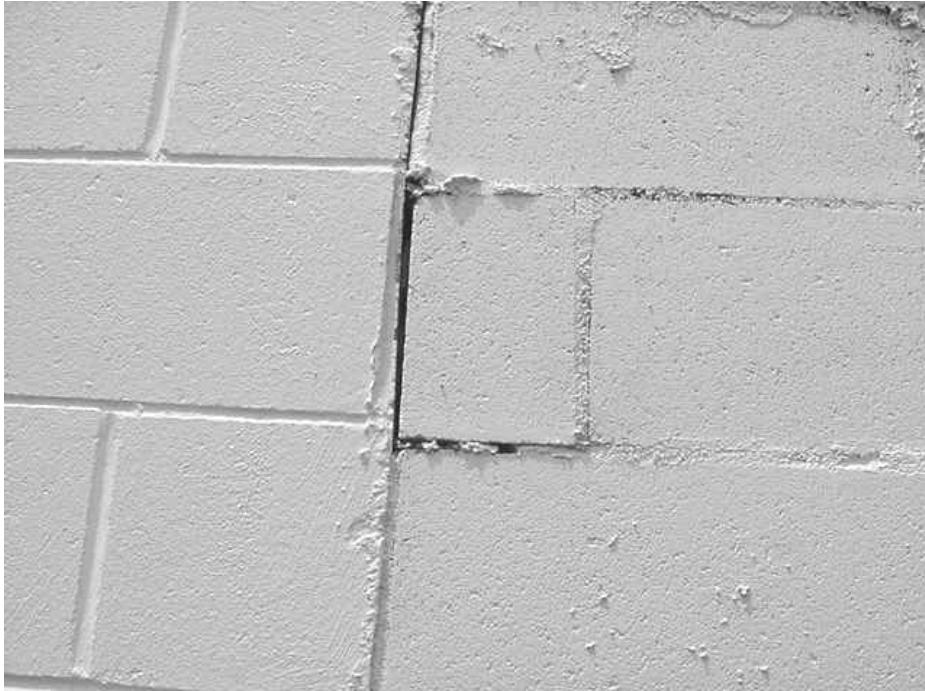
Picture 10b

Seal Doorway with Missing Sealant

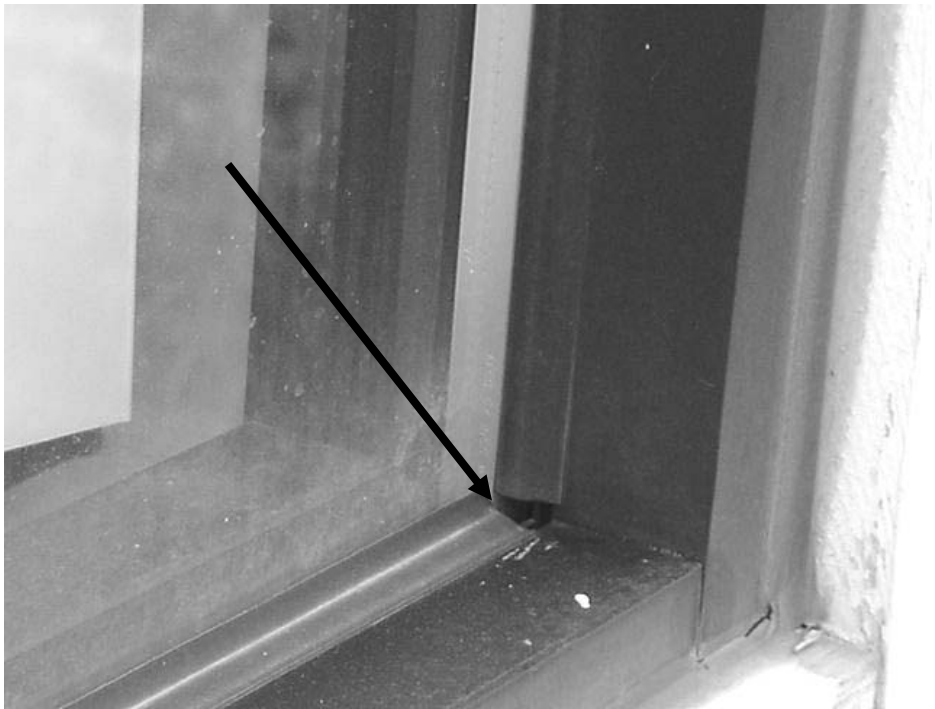
Picture 10c

Space in Window Gasket

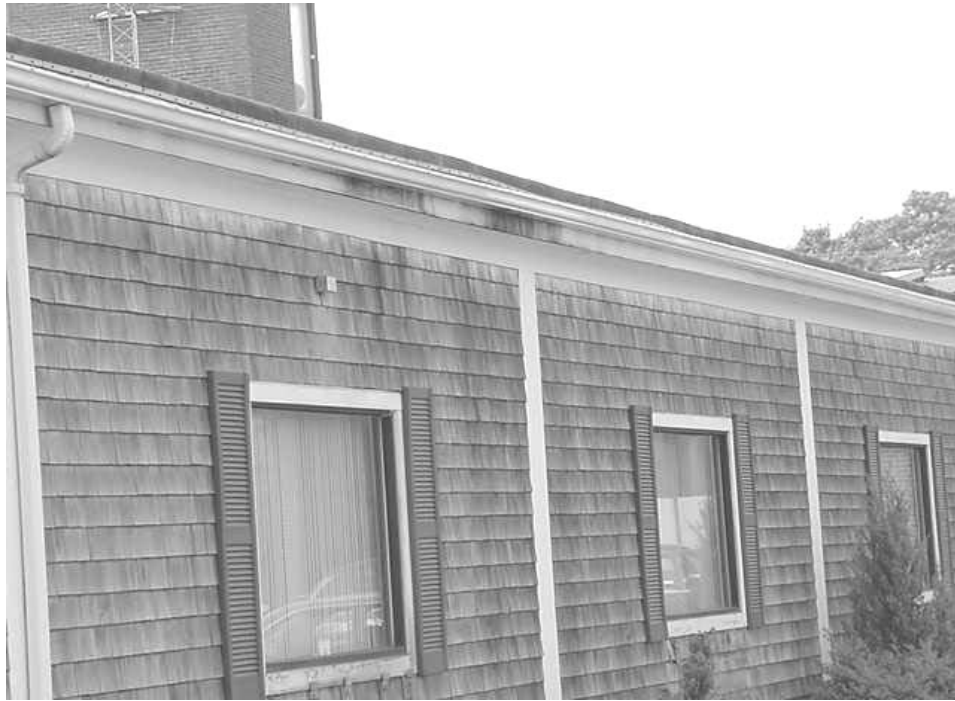
Picture 11

cladding of the addition appears to be cedar shingle framed by white painted planking (see Picture 11). A seam is formed where dissimilar materials meet. These junctions require sealing to prevent water penetration. It is a common practice to install flashing in the joints where dissimilar building materials are used in the building envelop. The flashing functions as a transitional surface for rainwater to drain from one surface to another (e.g. in a manner similar to layering shingles on a roof). Flashing was installed along the top of a window frame (see Picture 12) and at the shingle/planking junction above the building slab (see Picture 13). Of note is the lack of flashing beneath the window frames (see Picture 14). This lack of flashing creates an open seam (see Picture 15) that can allow for water penetration into the building interior. The collection of water against the window frame in this vulnerable spot is enhanced by window boxes affixed beneath the window seams. As rainwater pours onto the shingles and frames, water accumulates behind the window boxes, resulting in chronic wetting and degradation of building materials.

Exterior Cladding of the Addition

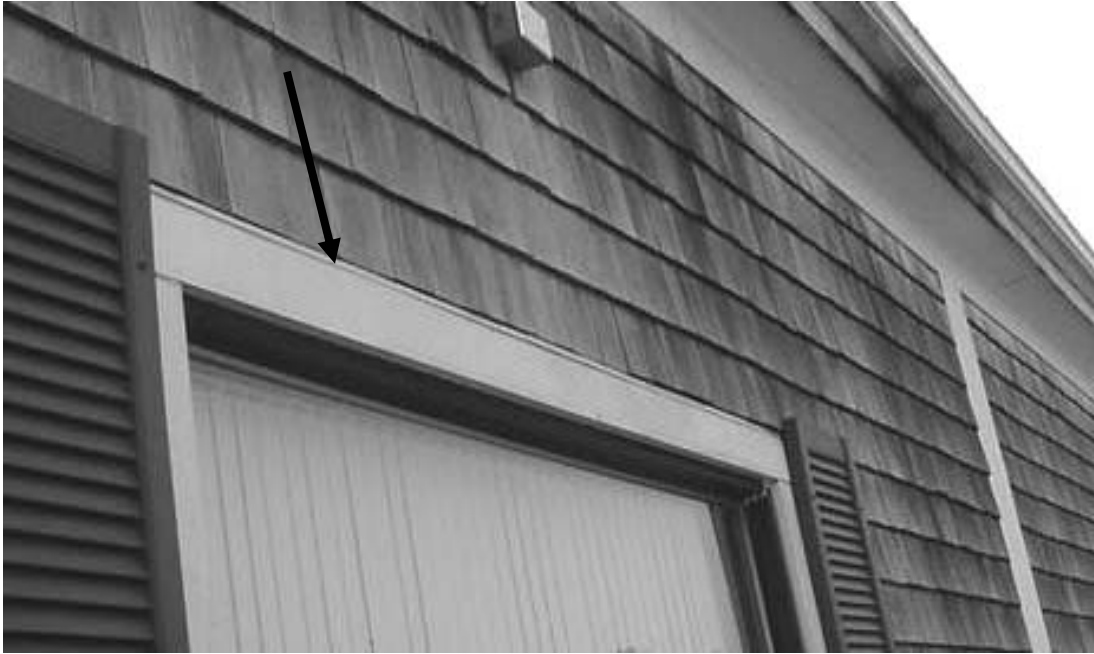
Picture 12

Flashing Installed along the Top of Window Frame

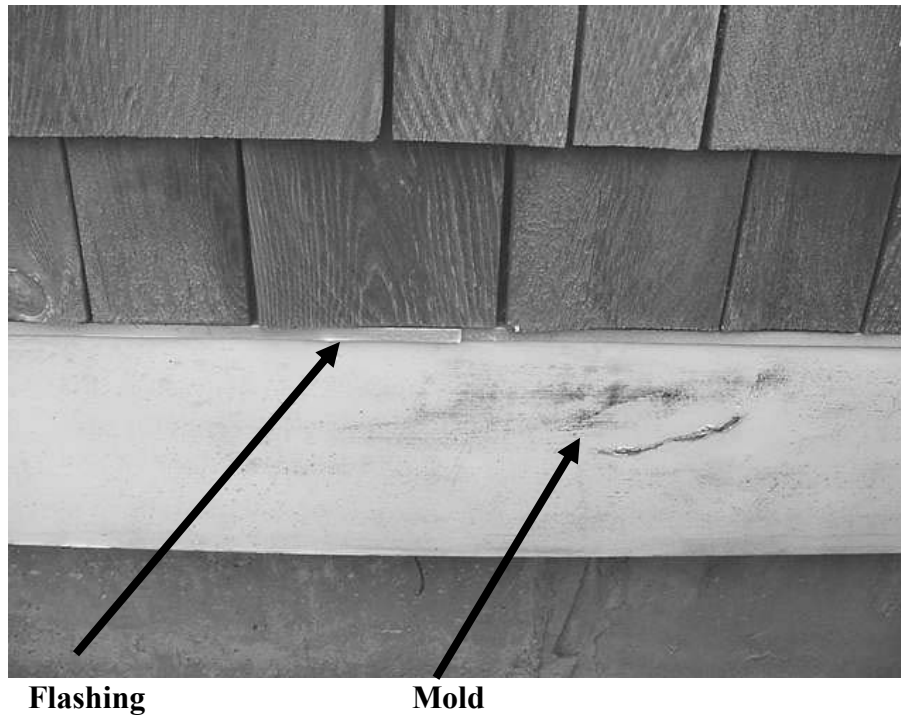
Picture 13

Flashing Installed along Shingle/Planking Junction above the Building Slab, Note Possible Mold on Plank

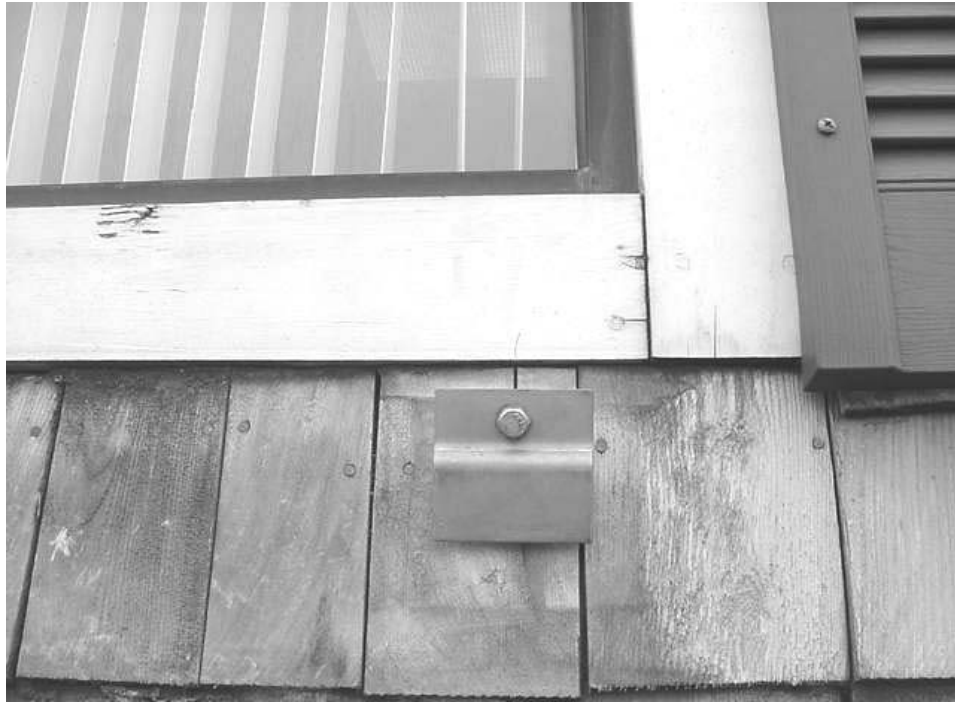
Picture 14

The Lack of Flashing beneath the Window Frames of the Addition

1. Examine the feasibility of installing a filter rack in the AHU system nearest to the AHU fan to filter both indoor/outdoor air and increase HVAC filter efficiency. Note that prior to any increase of filtration, each unit should be evaluated by a ventilation engineer so as to whether they can maintain function with more efficient filters.
2. Examine the feasibility of installing flashing along the base of the windows of the addition.

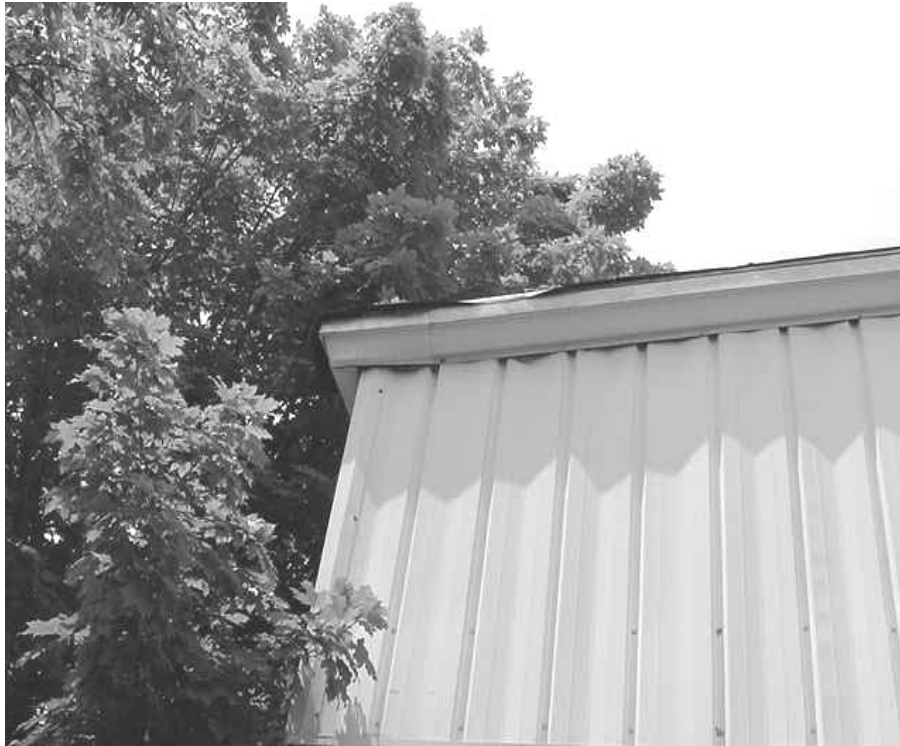
Picture 15

Several additional conditions exist that may result in water penetration into the building. The southwest corner of the roof appears to have a rubber membrane protruding upwards, instead of being fastened to the wall system (see Picture 15). Detachment of the rubber membrane from the wall system prevents the membrane to function as designed. Rather than preventing water entry, the unfastened rubber membrane allows water to penetrate the building.

Non-Adhered Membrane at Southwest Corner of the Roof

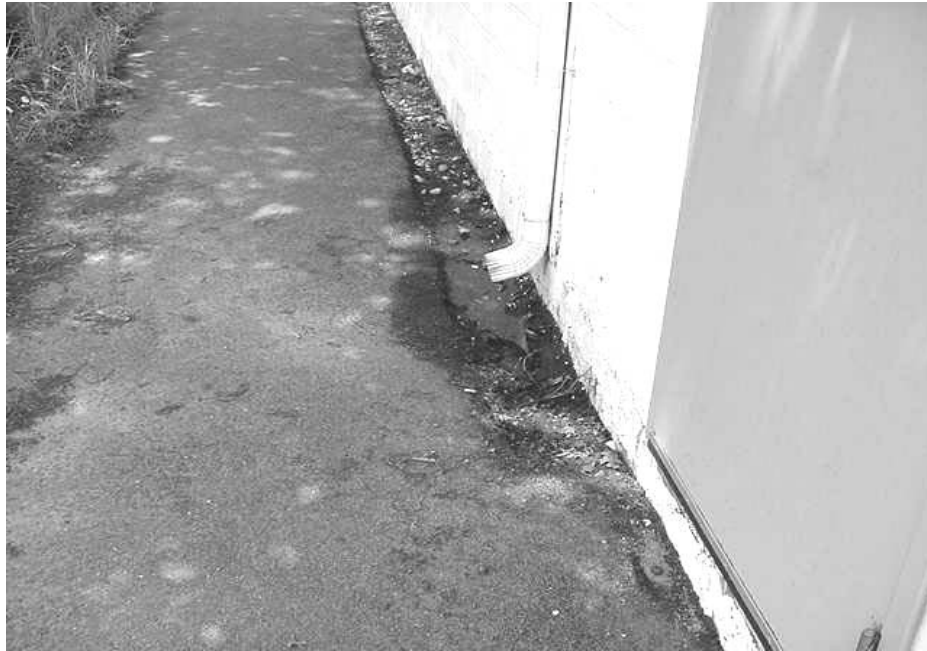
Picture 16

Another source of moisture penetration is chronic water damage to the exterior wall system/slab at the rear of the building (see Picture 16), resulting from prolonged contact with pooling rainwater. The roof at the rear of the building is outfitted with a drainage system that is connected to downspouts. Downspouts are configured to allow rainwater to accumulate at the base of the slab at the rear of the building (see Picture 17). This causes chronic wetting of the exterior wall. Downspouts should be designed to direct rainwater *away* from the base of the building to prevent rainwater from penetrating through the slab/exterior wall seam into the building interior. Water penetration can cause the moistening of GW and result in mold growth.

Pooled Rainwater at the Rear of the Building

- a. Improve the grading of the ground away from the foundation at a rate of 6 inches per every 10 feet (Lstiburek & Brennan, 2001).
 - b. Install a water impermeable layer on ground surface (clay cap, asphalt, cement) to prevent water saturation of ground near foundation (Lstiburek & Brennan, 2001).

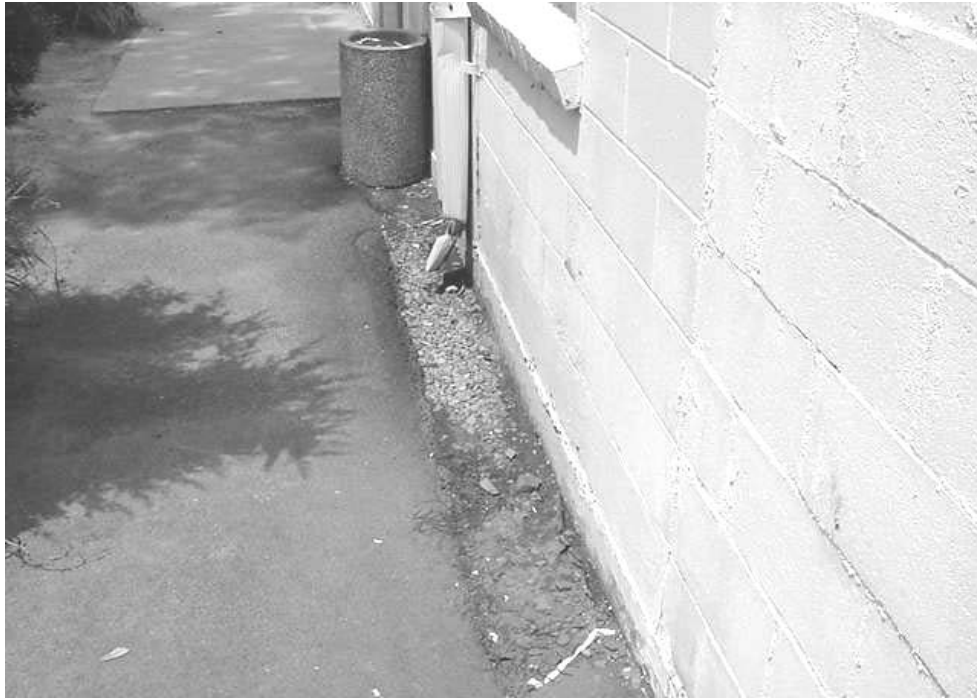
Picture 17

**Downspouts Are Configured To Allow Rainwater to Accumulate
at the Base of the Slab at the Rear of the Building**

8. Once both the fresh air supply and exhaust ventilation are functioning, the systems should be balanced by a ventilation engineering firm.
9. Examine the feasibility of directing downspout water away from the base of the exterior wall.

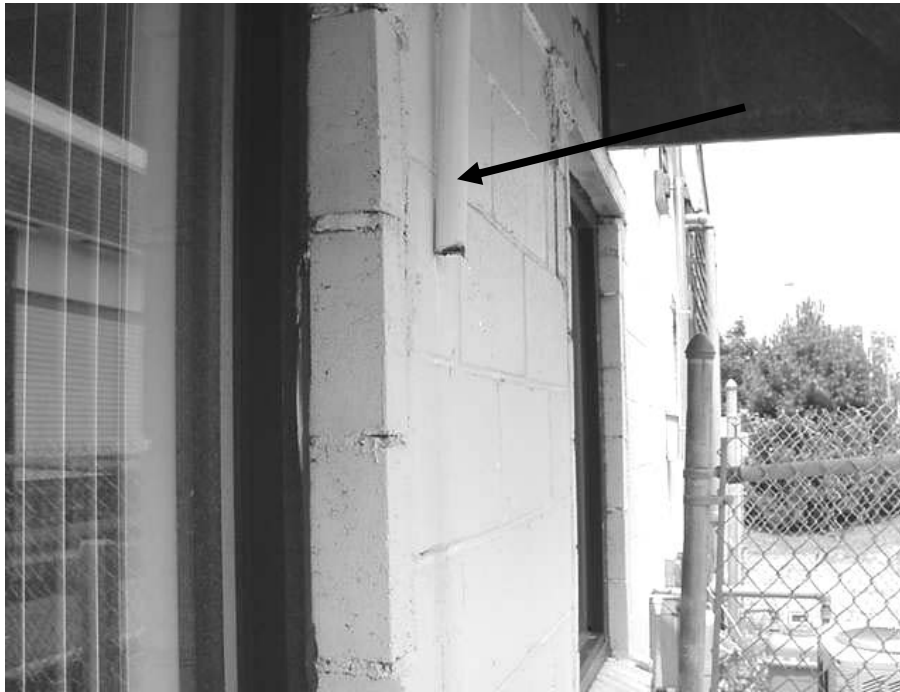
Picture 18

An additional source of exterior wall moistening is the location of condensation drains for the HVAC system. The condensation drain for the original building is located several feet above a cement slab (see Picture 18), allowing water to continuously moisten the exterior wall (see Picture 19). Condensation drains for the addition appear to empty directly onto cedar shingles. The configuration of both condensation drains produce chronic wetting of the exterior wall, which may result in moisture penetration into the building.

Condensation Drain for the Original Building Is Located Several Feet above A Cement Slab

5. Add extensions to condensation drains to deliver water to the ground without splashing.
6. Remove window boxes on windows of the addition.
7. To maximize air exchange, the BEHA recommends that all ventilation systems that are operable throughout the building operate continuously during periods of occupancy independent of thermostat control. To increase airflow in classrooms, set univent controls to "high". Set univent thermostats to the fan "on" position to operate the ventilation system continuously during the workday.

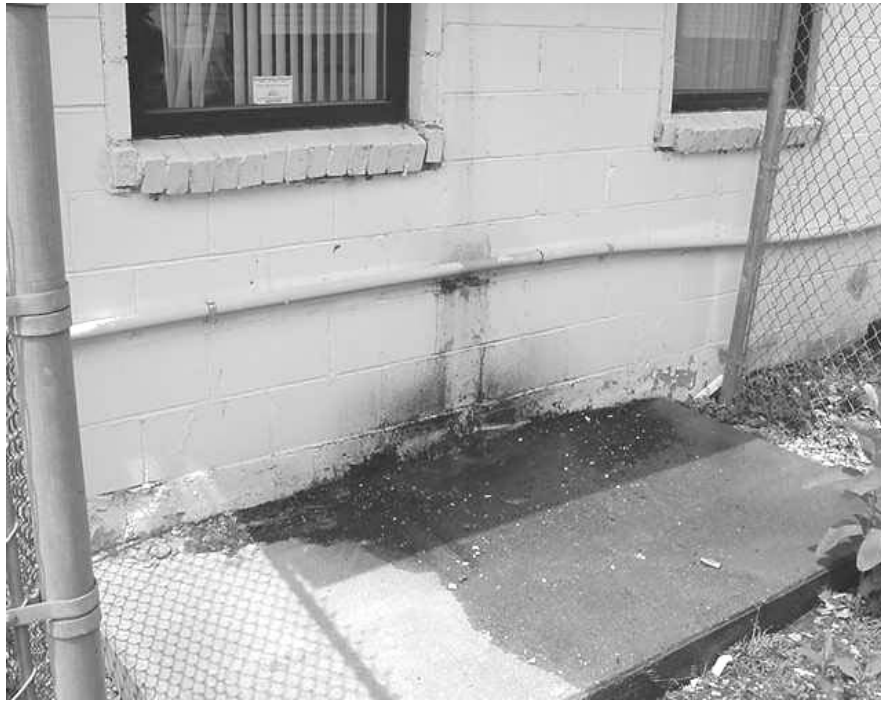
Picture 19

Effects of Condensation Moistening the Exterior Wall

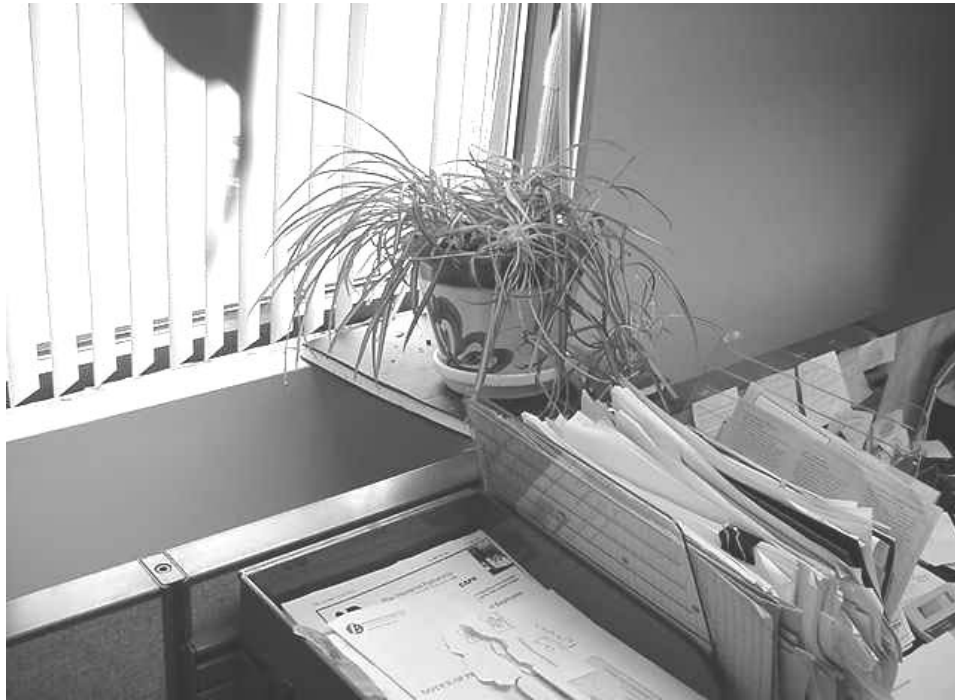
Picture 20

Several areas also have a number of plants (see Picture 20). Plant soil, standing water and drip pans can be potential sources of mold growth. Drip pans should be inspected periodically for mold growth and over watering should be avoided.

Plant on Work Area

10. Consider reducing the number of plants away from univents in work areas. Avoid over-watering and examine drip pans periodically for mold growth. Disinfect with an appropriate antimicrobial where necessary.

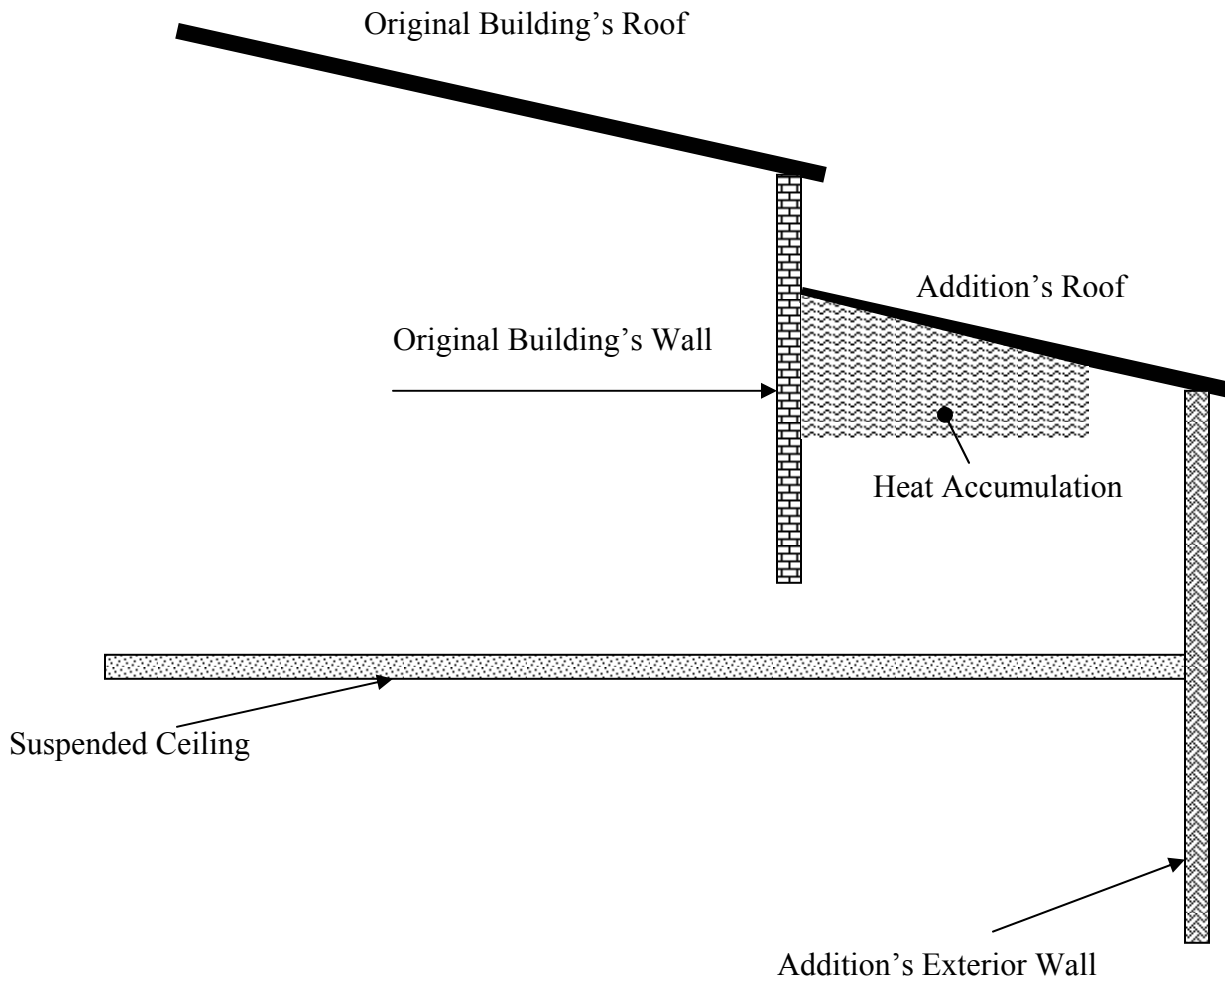
Figure 1

The roof appears likely to form ice dams during winter months, which can also be a source of water damage. Ice dams form when snow in contact with the upper section of the roof melts, then refreezes on the lower portion of the roof. Melting occurs as a result of heated air generated from occupied spaces and the HVAC system. The heated air gathers in the peak of the roof, which warms the roofing material above water's melting point (32° F). As water rolls down the sloped roof, it freezes into ice when it comes into contact with roof materials on the lower section of the roof that are below 32° F. This ice creates a dam, which then collects and holds melting snow or rainwater against the roof shingles. Pooling water can then penetrate through the roof materials via cracks and crevices, resulting in wetting of the interior of the building. In order to prevent ice dams, a combination of methods are used. For example, the space between rafters in the ceiling can be insulated to prevent air movement and heat loss. The junction between the original building and the addition could not be examined during the assessment. However, if the wall of the original building extended below the level of the peak of the addition roof, a space is created where heated air may accumulate (see Figure 1). Heat can also accumulate in this space and start the ice dam creation cycle, particularly if attic insulation were inadequate. The problem is further compounded if insulation were moistened as a result of the ice dams. The ability of insulation to prevent temperature transfer is decreased if the material

becomes moistened. The loss of temperature control can increase heat transfer to the roof surface, creating larger ice dams and more water penetration. Water damaged ceiling tiles, insulation backing and adhesive can serve as mold growth media. The conditions contributing to the creation of the ice dams should be corrected to prevent moisture problems.

Configuration of Original Building and Addition's Junction that May Lead to Heat Accumulation and Ice Dam Generation

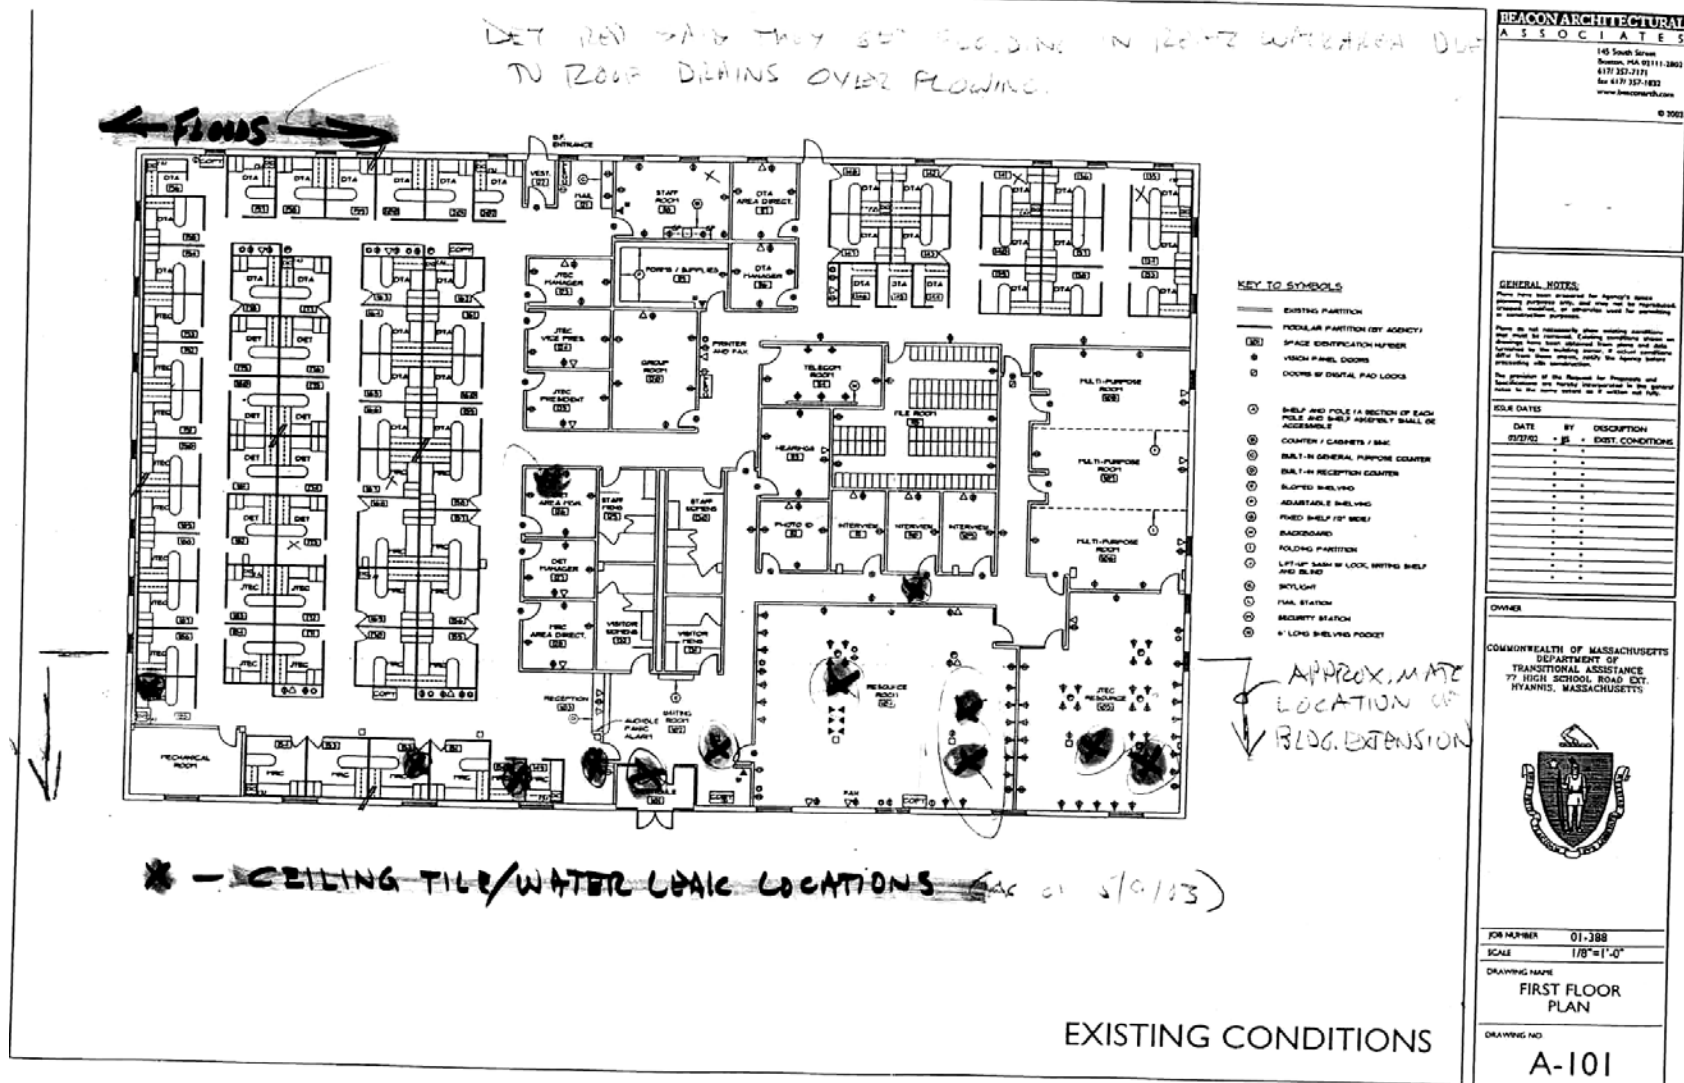
Figure 2

The configuration of the roof system in the front of the building may provide another means for water penetration. Prior to the assessment, building occupants reported that water damaged ceiling tiles were replaced, mostly in areas that are within the footprint of the addition (areas 101, 102, 104, 105, 149, 150, 152 and 185; see Figure 2). The location of water damaged ceiling tiles suggests water is penetrating from an external source. As previously mentioned, the addition's roof is not flush with the original roof, but rather is installed a foot below the level of the original roof (see Picture 4). In this configuration, rainwater that accumulates on the front side of the original roof, pours onto the lower roof in a waterfall-like manner, and then streams off the edge of the lower roof. However, some rainwater does splash against the exterior wall component, between the original roof and the lower roof installed for the building addition. In

the BEHA's experience, seams between sections of a building that are constructed at different times are usually vulnerable to breach by rainwater. In this case, water penetration has occurred, as evidenced by the water damaged ceiling tiles. A rubber membrane should be installed in this vertical section of roof to provide a continuous surface for rainwater transfer. A gutter downspouts system should also be installed to direct rainwater away from the vulnerable wall section between the original and lower roof.

Location of Water Damaged Ceiling Tiles Identified by Building Occupants
